## COLORADO CULTURAL RESOURCE SURVEY

**Architectural Inventory Form**

1. Resource number: **5BL.1264** Parcel number(s): **131502206030**  
 2. Temporary resource number: **N/A**  
 3. County: **Boulder**  
 4. City: **Longmont**  
 5. Historic Building Name: **Abbott Farmhouse**  
 6. Current Building Name: **Daniel House**  
 7. Building Address: **720 Martin Street**  
 8. Owner Name: **Daniel, Ronald Frederick**  
 Owner Organization:  
 Owner Address: **720 Martin St**  
**Longmont , CO 80501**

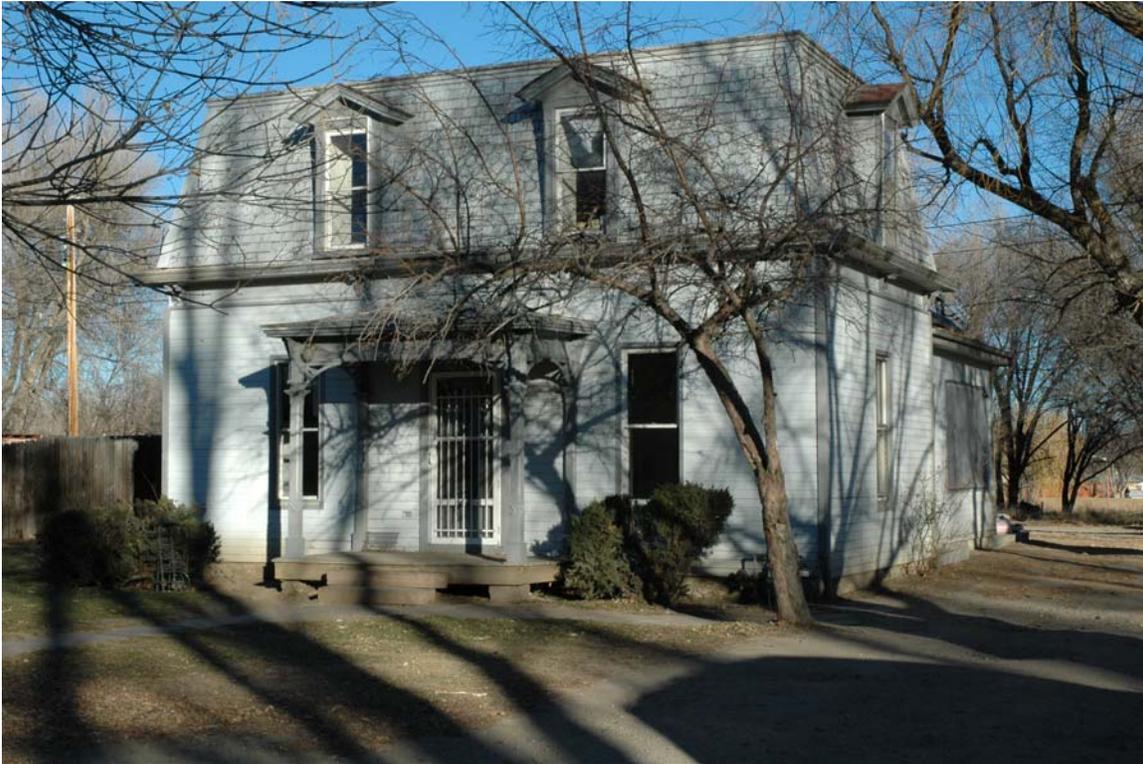
**Porch**  
**Garage/Attached Garage**
21. General architectural description:  
**The building at 720 Martin Street presently consists of the original, 1890s, French Second Empire style farmhouse, with a large addition (or additions) to the east (rear) elevation, including an attached double-stall garage. The original farmhouse, with a Mansard roof, measures 28' N-S (across) by 20' E-W (deep). It is supported by a low sandstone foundation, and its exterior walls are clad with painted pale blue horizontal wood siding, with painted blue/grey 1" by 4" corner boards. The Mansard roof is covered with deteriorated grey asphalt composition shingles, and the eaves are boxed. Two gabled dormers, each with a 1/1 double-hung sash window, overlook the symmetrical façade on the west elevation. Single gabled dormers, also with 1/1 double-hung sash windows, are located on the north and south elevations. The original house's main level windows also appear to be entirely 1/1 double-hung sash, with painted wood frames and surrounds. A white paneled front entry door, covered by a white metal security door, is centered on the façade. This door leads into the house from a 3-step porch which features a wooden floor, painted grey square columns with decorative brackets, and a low-pitched hipped porch roof.**

- The rear (east elevation) addition have more than doubled the size of the original dwelling. Covered by a gabled roof, an L-shaped addition, overall, measures 37' N-S by 24' E-W. An attached, gabled, garage addition, which measures 16' N-S by 18' E-W, is then attached to the east elevation of the L-shaped addition. These addition(s) are supported by a concrete foundation, and are built of wood frame construction, with horizontal exterior wood siding. Entry doors, and two roll-away garage doors, are located on the south elevation.**

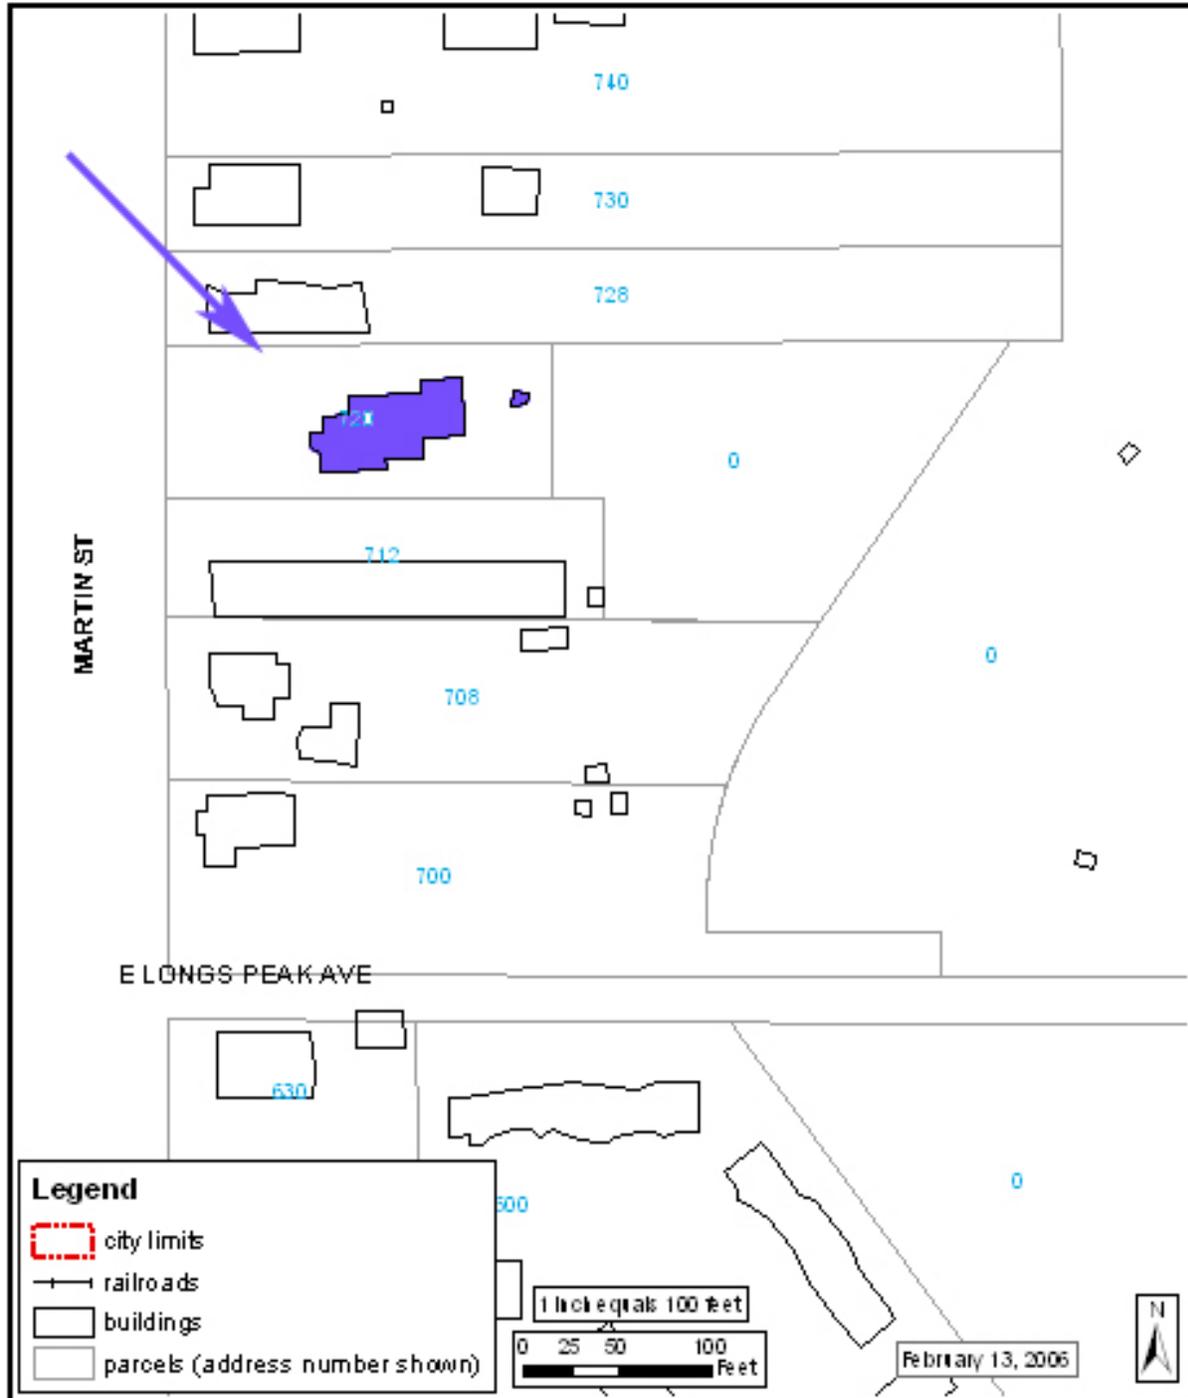
## Sketch Map

22. Architectural style: **Late Victorian/Second Empire**  
 Building type:
23. Landscape or special setting features: **This property is located on the east side of Martin Street, north of Longs Peak Avenue, just east of the eastern periphery of Longmont's historic East Side residential neighborhood. Situated on a large lot, the house is set well back from the street. The house and grounds appear to be in poor condition, and are not being well-maintained.**
24. Associated buildings, features or objects:  
 1: Type: **Shed (ruins)** Contributing? **Noncontributing**  
 Describe: **The deteriorating ruins of some type of historic outbuilding are located north east of the house.**
